PRELIMINARY UPLAND ASSESSMENT REPORT  
MC CONKEY/SESKO SITE  
1725 PENNSYLVANIA AVENUE  
BREMERTON, WASHINGTON

SEPTEMBER 20, 2007

**PRELIMINARY UPLAND ASSESSMENT REPORT  
McCONKEY/SESKO BROWNFIELD SITE  
BREMERTON, WASHINGTON**

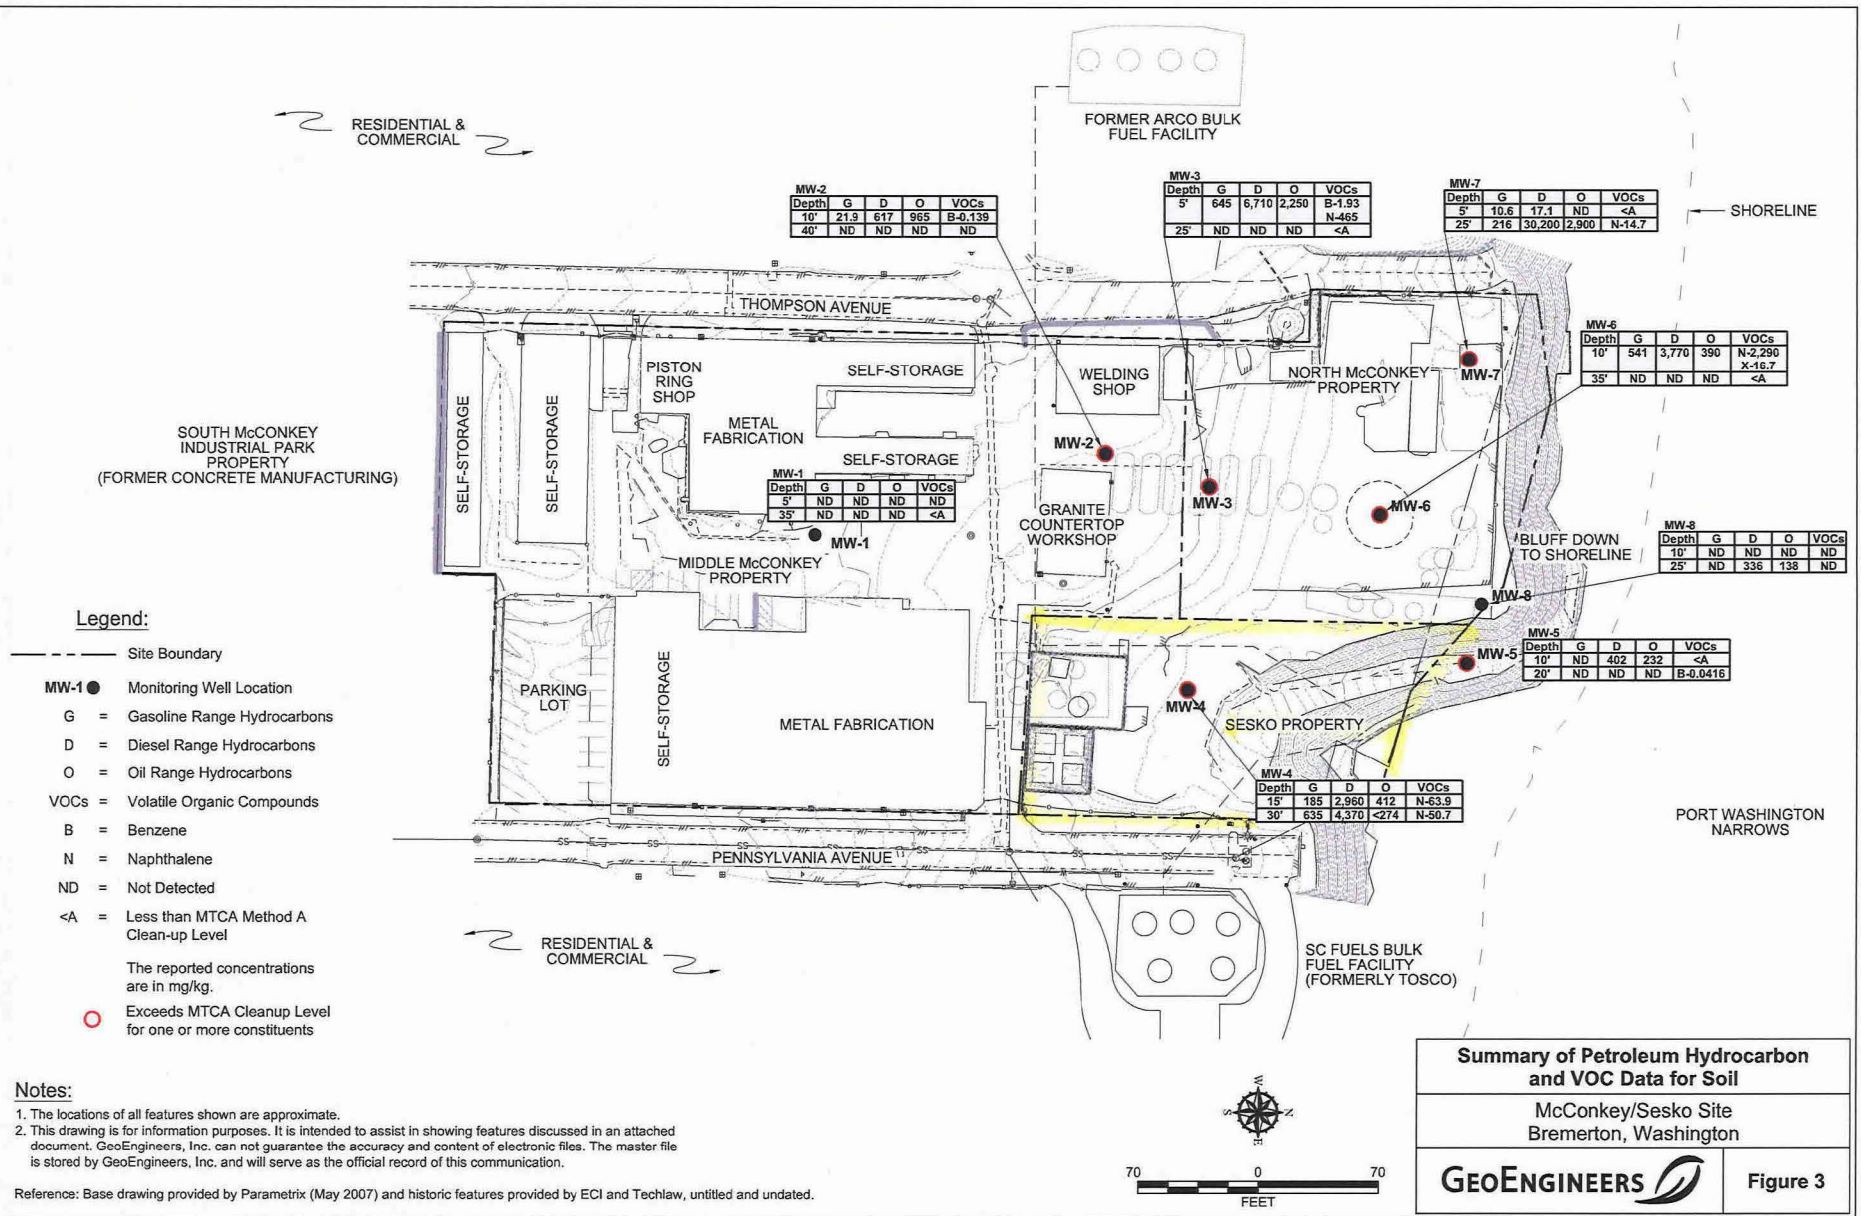
Gasoline-, diesel-, and oil-range hydrocarbons and/or VOCs were reported in the soil samples tested from each of the eight soil borings completed at the Site. The gasoline- and diesel-range hydrocarbons concentrations reported in the soil samples collected from MW-3 (at 5 feet bgs), MW-4 (at 15 and 30 feet bgs), MW-6 (at 10 feet bgs), and MW-7 (at 25 feet bgs) exceeded the MTCA Method A cleanup levels for the constituents identified. In addition, the oil-range hydrocarbons concentration reported in the soil sample collected from MW-3 (at 5 feet bgs) exceeded the MTCA Method A cleanup level for oil-range hydrocarbons. Benzene, naphthalene, and xylenes were also reported at concentrations exceeding their respective MTCA Method A cleanup levels at multiple locations throughout the Site (see Figure 3).

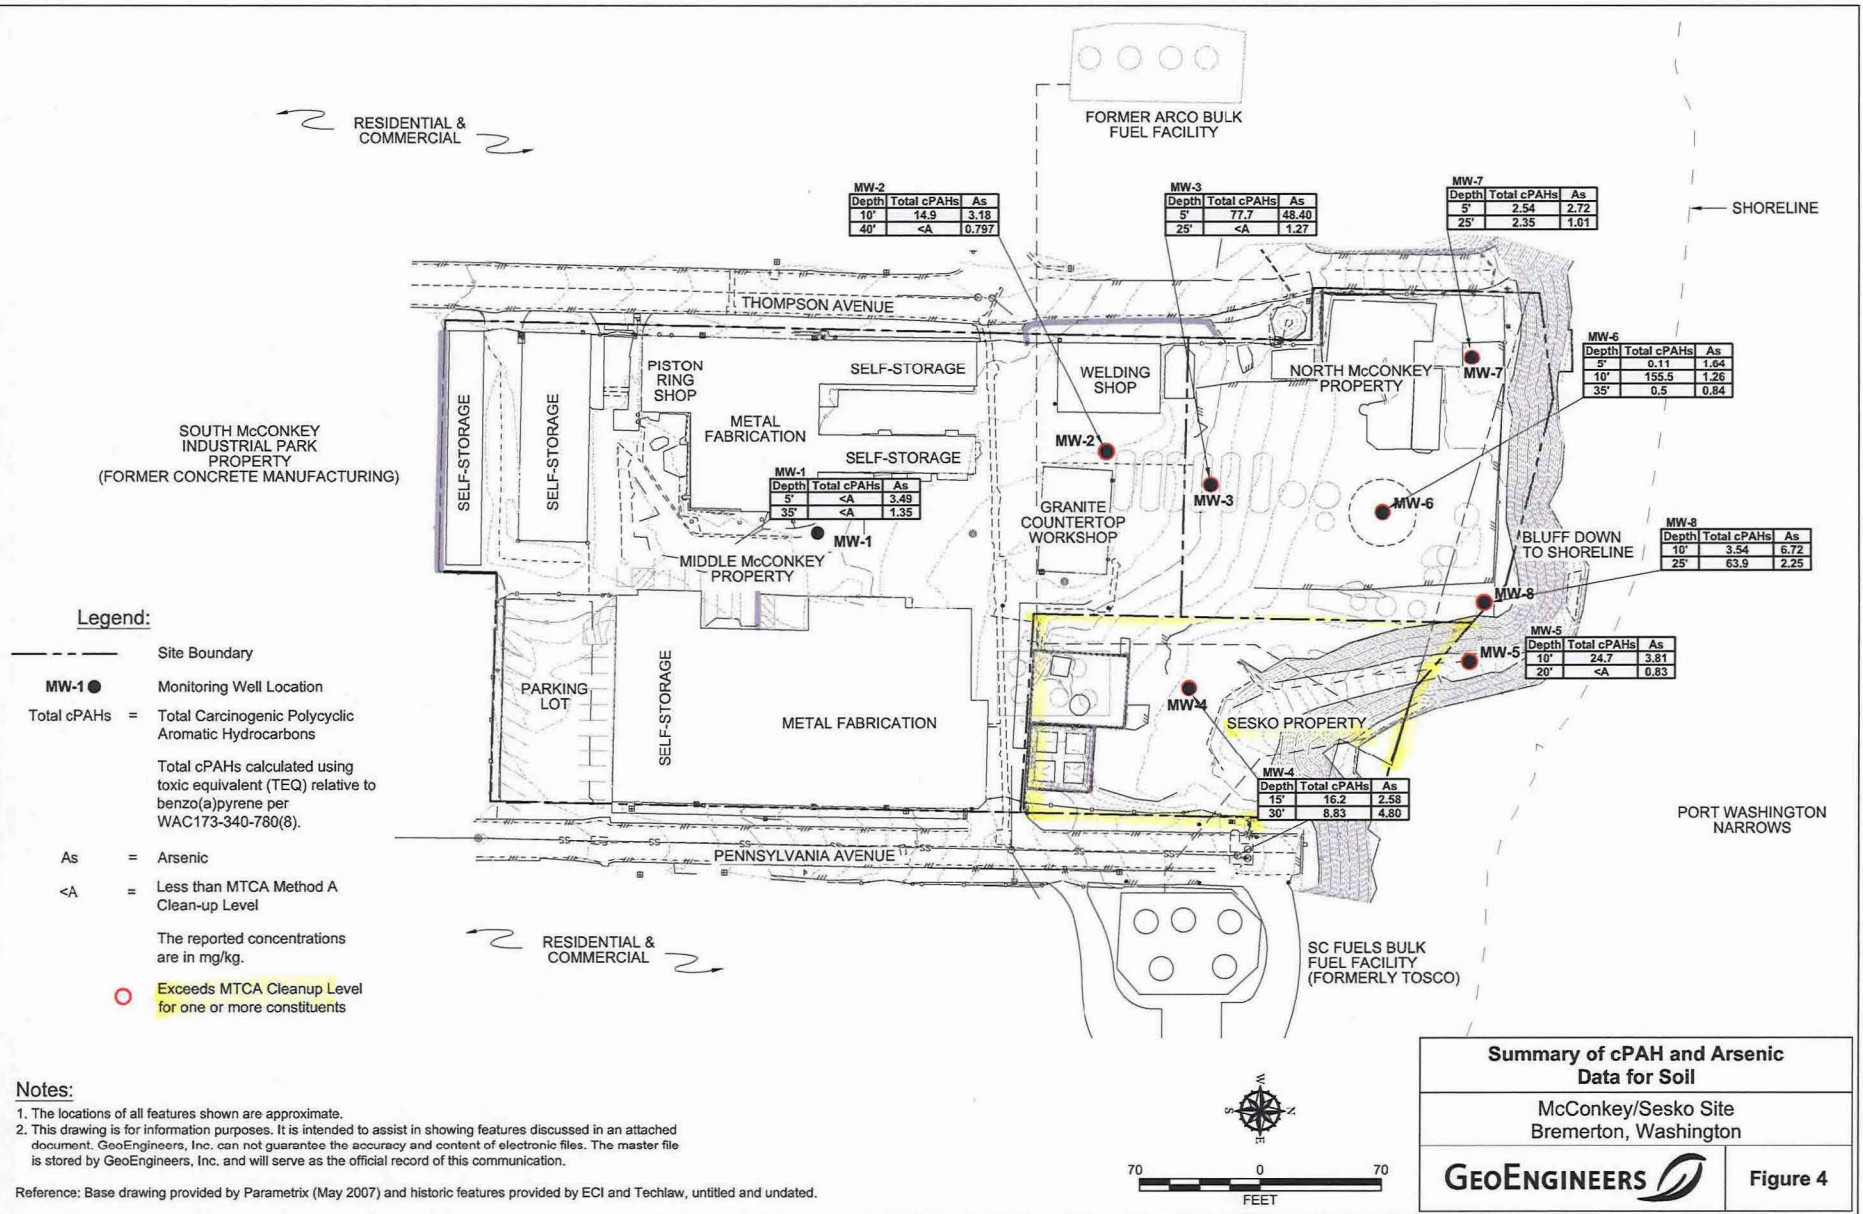
Arsenic was reported at a concentration of 48.4 milligrams per kilogram (mg/kg) in 1 of the 17 samples submitted for analysis for this constituent. This reported concentration exceeds the MTCA Method A cleanup level for arsenic of 20 mg/kg. The remaining metals were either not identified at concentrations above the laboratory's sample quantitation limit, or were reported at concentrations that do not exceed the applicable MTCA Method A cleanup levels. PCBs were not detected in any of the soil samples submitted for chemical analysis from the Site.

SVOCs and PAHs were reported in 14 of the 17 soil samples collected throughout the Site. Laboratory-reported carcinogenic polycyclic aromatic hydrocarbon (cPAH) concentrations from twelve of the sample locations exceeded the MTCA Method A toxicity equivalent (TEQ) value for total cPAHs of 0.1 mg/kg. The

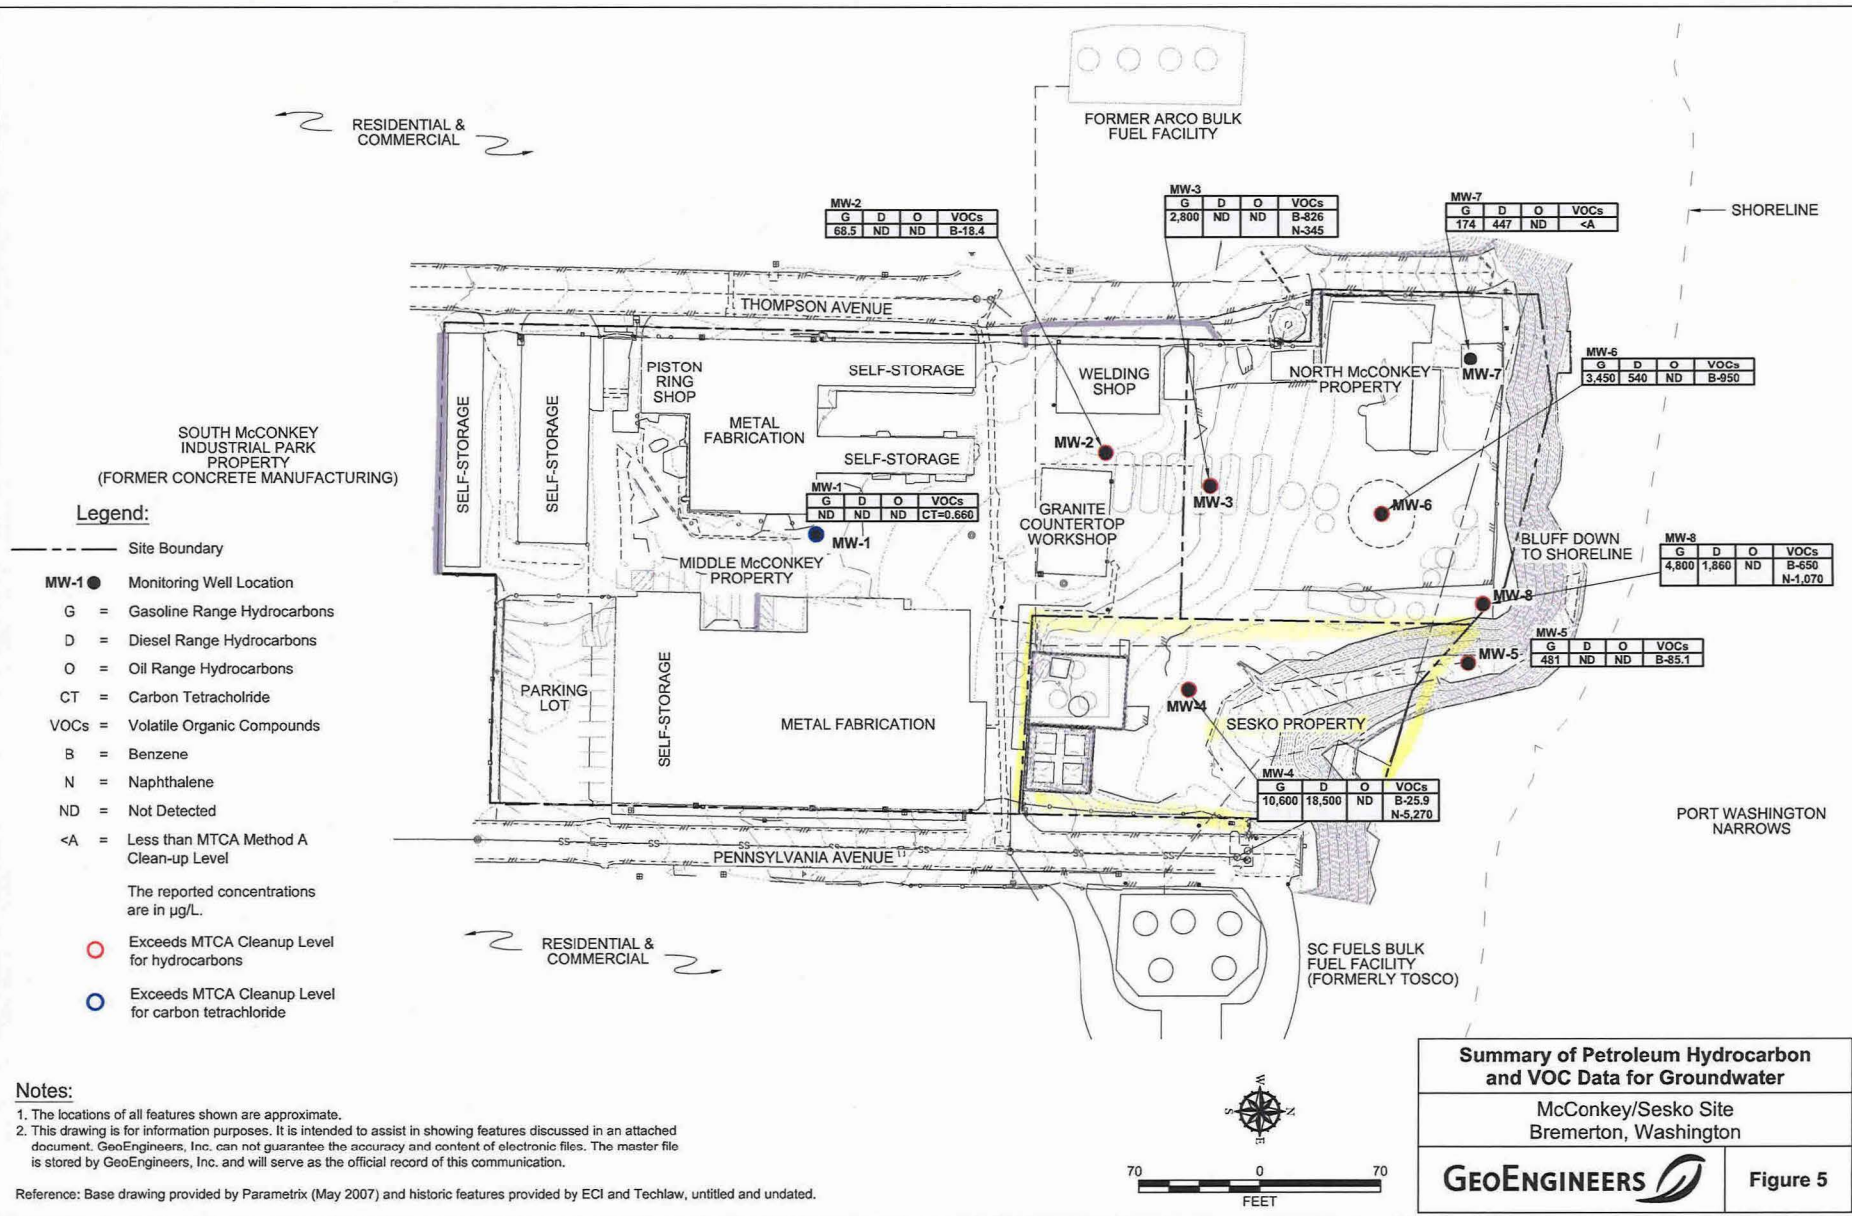
Gasoline-, diesel-, and oil-range hydrocarbons and/or VOCs were identified in each of the nine groundwater samples collected from the property. The gasoline- and diesel-range hydrocarbons concentrations reported in the groundwater samples collected from MW-4, MW-6, and MW-8 exceeded the MTCA Method A cleanup levels for the constituents identified. In addition, the gasoline-range hydrocarbons concentration reported in the groundwater sample collected from MW-3 exceeded the MTCA Method A cleanup level for gasoline-range hydrocarbons. Benzene, naphthalene, and carbon tetrachloride were also reported at concentrations exceeding their respective MTCA Method A cleanup levels (or Method B cleanup level in the case of carbon tetrachloride) at multiple locations throughout the Site (see Figure 5).
